12
FC
TECHNICAL REPORT M-186
August 1976

FAILURE ANALYSIS OF OZARK, ARKANSAS,
POWER PLANT SOCKET-HEAD CAP SCREWS

by
E. P. Cox

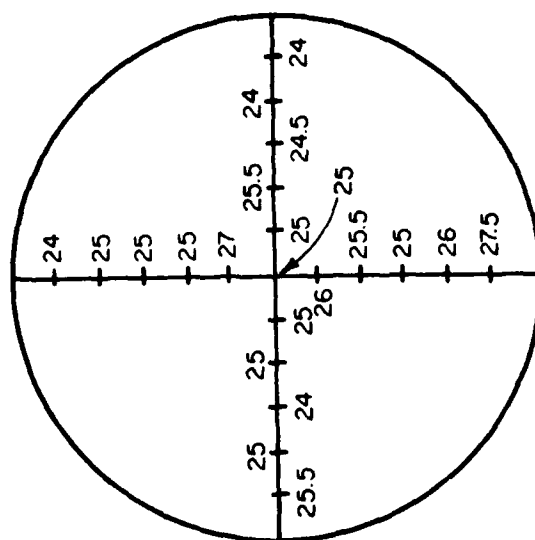
Results of the hardness surveys show that in each case the cap screw was too soft; i.e., hardness was less than the 38 to 45 R_C specified. The hardness over the cross section was generally uniform, with the threaded surfaces being somewhat harder than the centers. The low hardness readings indicate that the cap screws were improperly heat-treated and that manufacturer quality control was lacking.

Figure 6. Rockwell C hardness survey on cap screw #23 (a) and the numerical values (b), 1x.

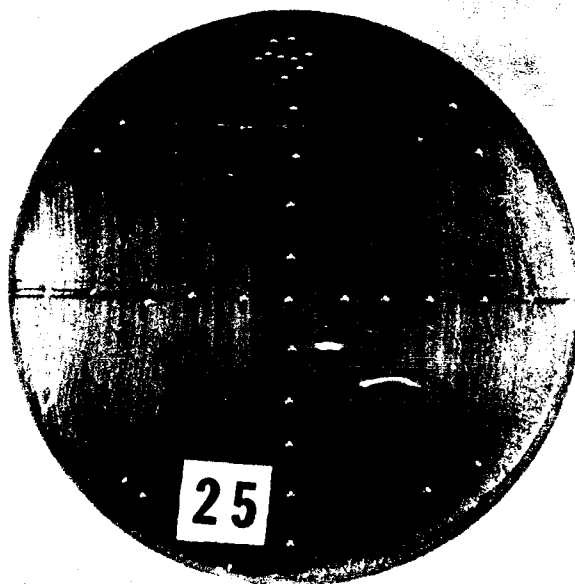
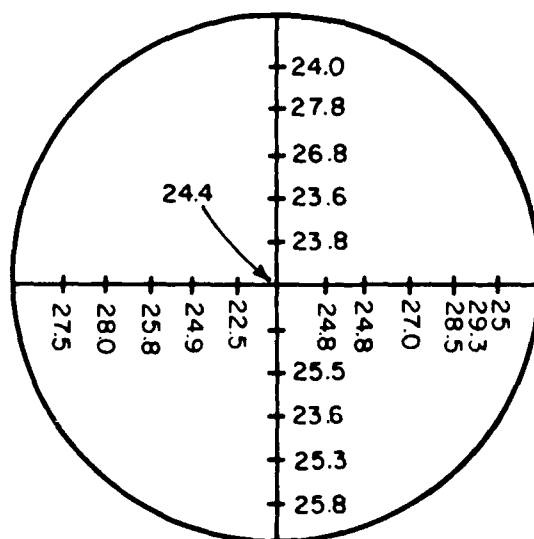
Figure 7. Rockwell C hardness survey on cap screw #25 (a) and the numerical values (b), 1x.

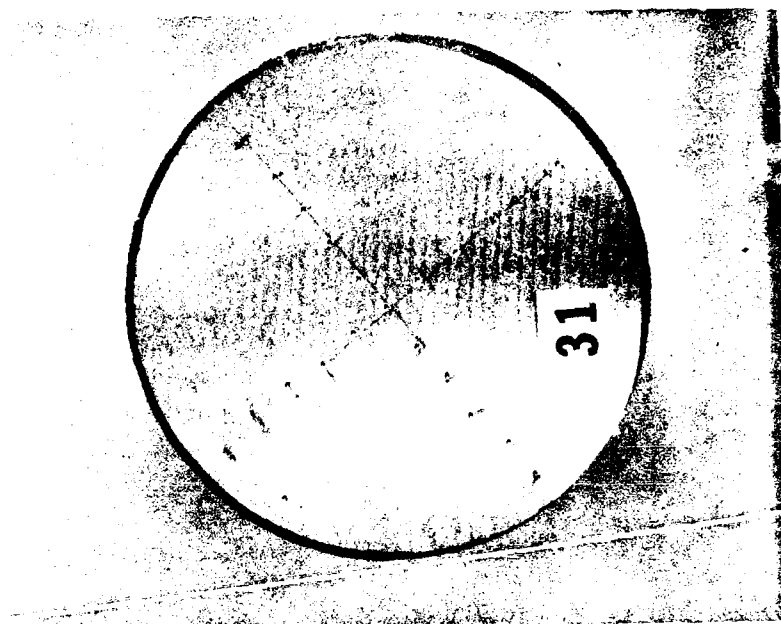
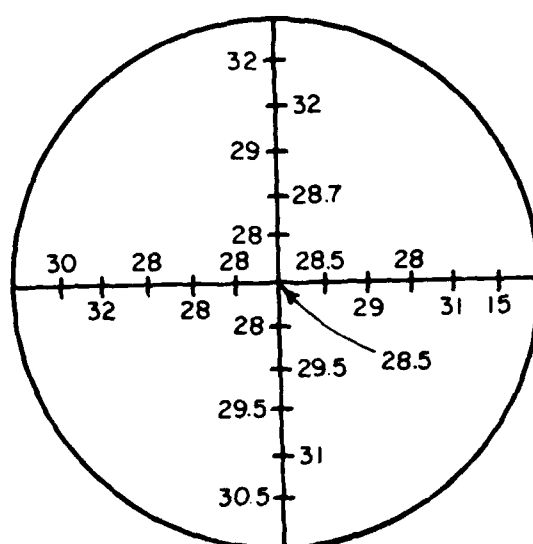
Figure 8. Rockwell C hardness survey on cap screw #31 (a) and the numerical values (b), 1x.

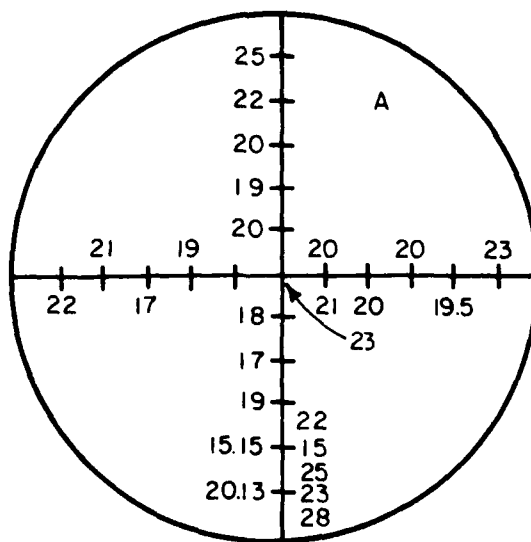
Figure 9. Rockwell C hardness survey on cap screw OZ (a) and the numerical values (b), 1x.
